Status of the S-DALINAC

S-DALINAC

Superconducting-**D**armstadt-**L**INear-**A**ccelerator

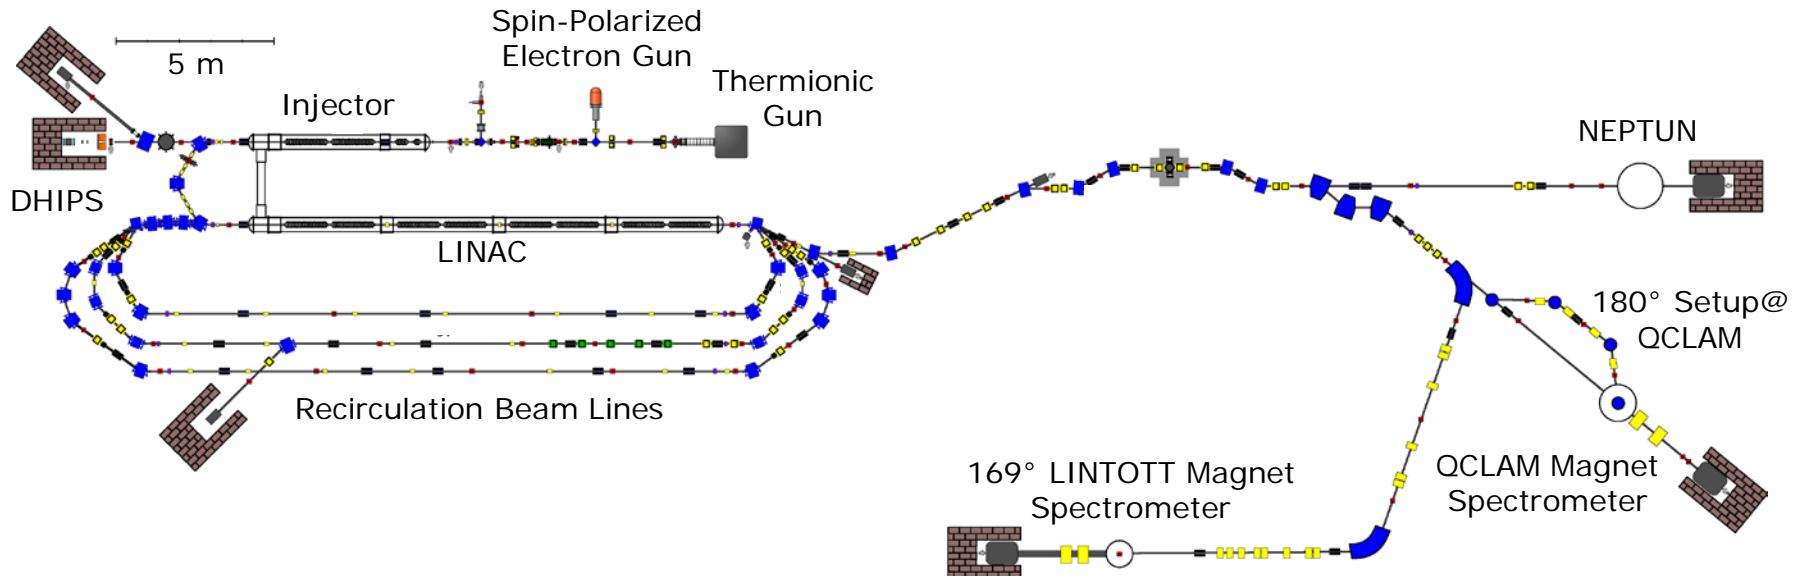
Thrice recirculating operation

Energy gain injector: 7.6 MeV

Energy gain LINAC: 30.4 MeV

Maximum energy: 129.2 MeV

Beam current: 20 μ A

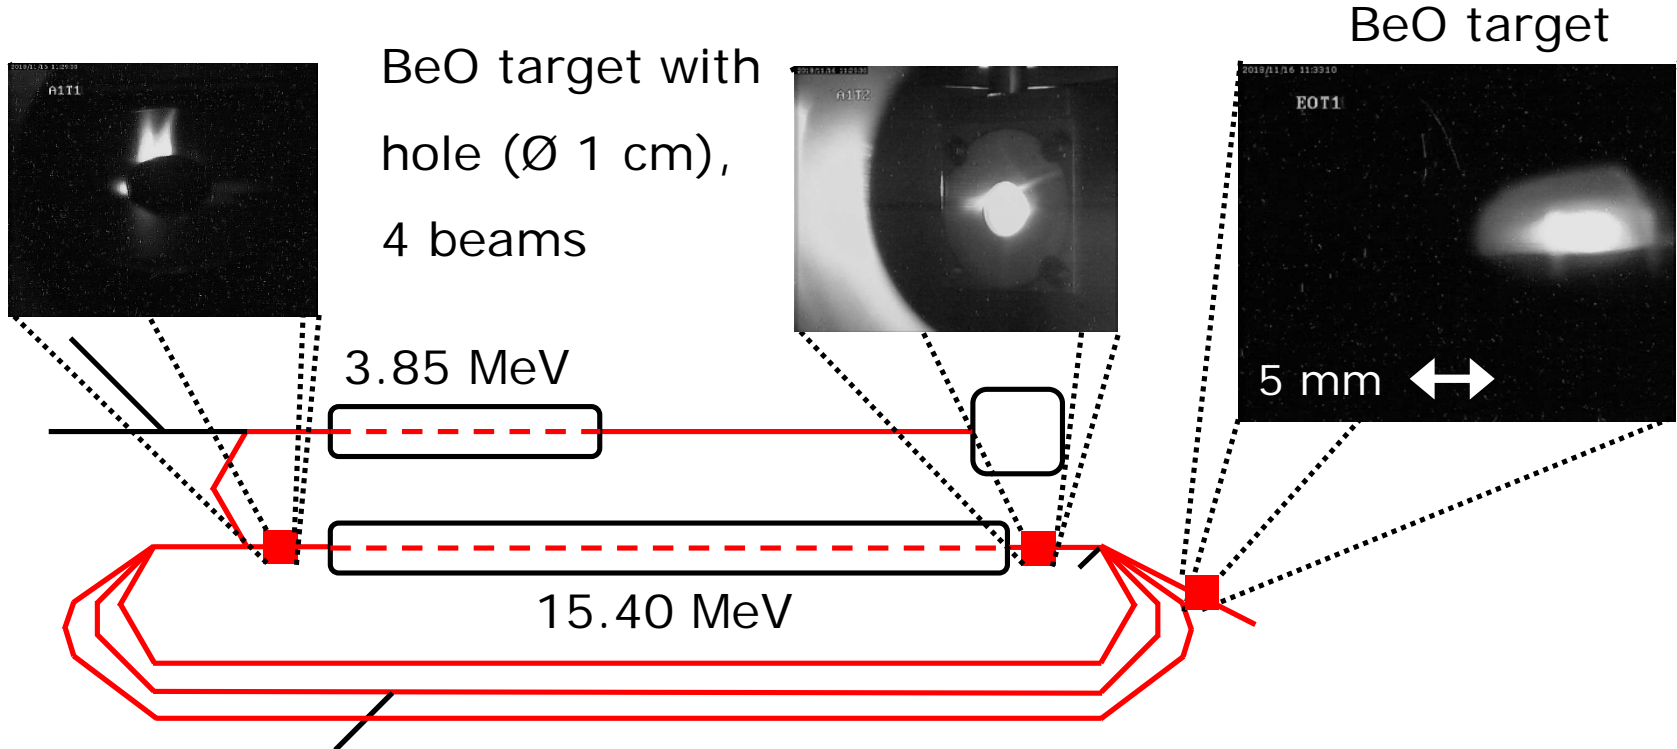
First Thrice-Recirculating Operation

- Up to $2.5 \mu\text{A}$ with $>90\%$ transmission (100% reached for smaller beam currents)
- Beam parameters measured

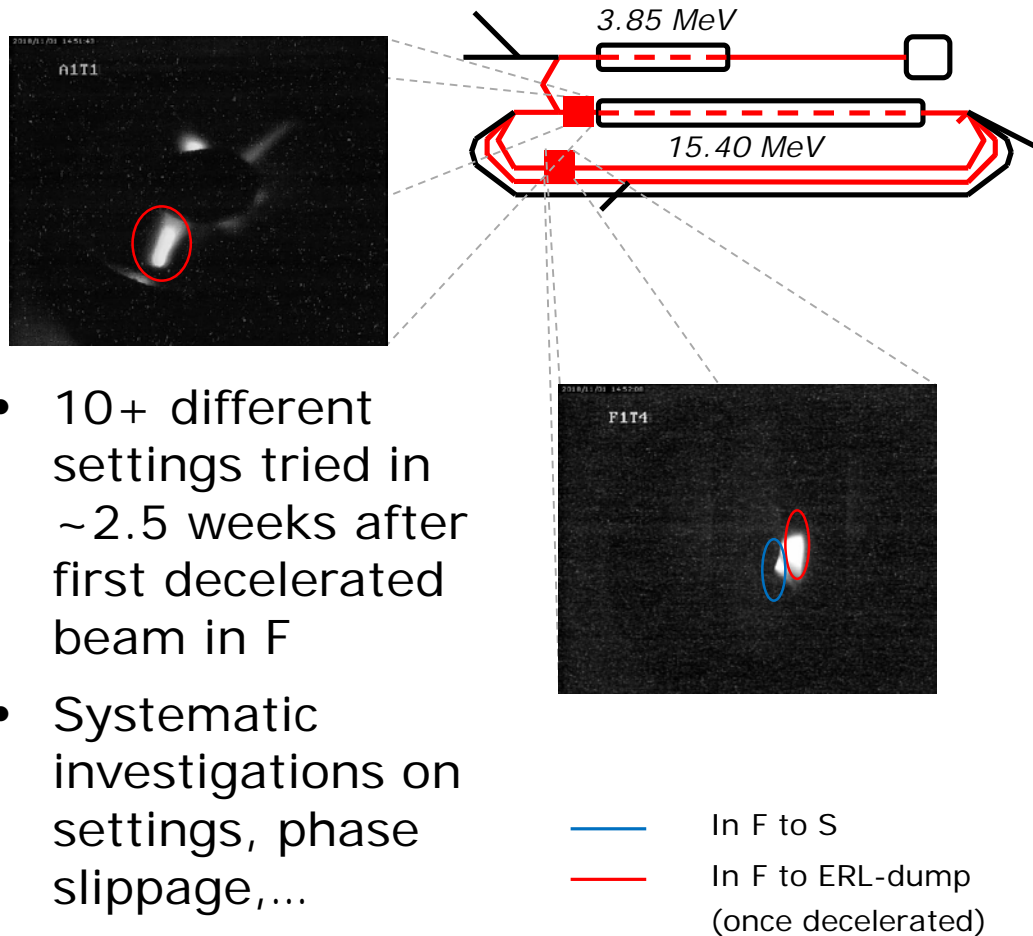
Test Phase Twice-Recirculating ERL

- 10+ different settings tried in ~2.5 weeks after first decelerated beam in F
- Systematic investigations on settings, phase slippage,...

Diagnostics

- Beam loading cavities (first decelerated beam in A1SC07 up to ~90% recovered)
- RF monitor system
- Beam loss monitor system
- BeO targets with hole on F1
- Check of path-length adjustment system position in S on T0 ($\rightarrow 180^\circ$)

Learned so far:

- ❖ Beam “blocked” in front of second deceleration
- Momentum deviation of centre particle
- Momentum spread increases starting with first deceleration
- ✓ Phase slippage must be controlled properly

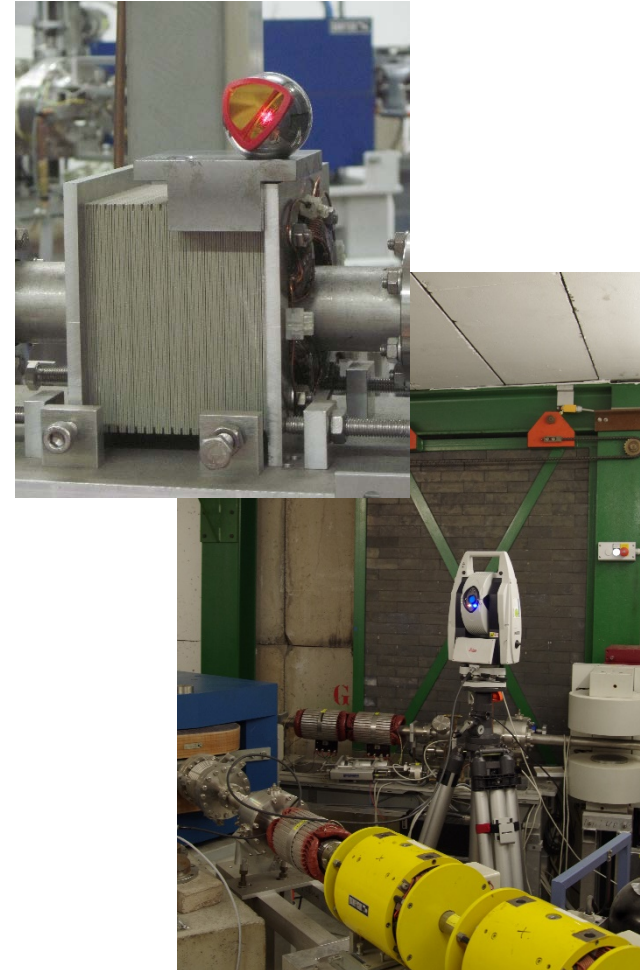
- Alignment of warm injector section, extraction beam line, DHIPS, NEPTUN, QCLAM, LINTOTT and correction of elements moved over time
- Learned: accelerator hall is „shrinking“ by $\sim 1\text{mm}/3\text{ years}$
- Improvement of stability
 - Ventilation and cleanliness in gun cage
 - Piping for LN2 exhaust (no temperature drifts for SMA-cables)
 - Less vibrations on beam in warm injector section

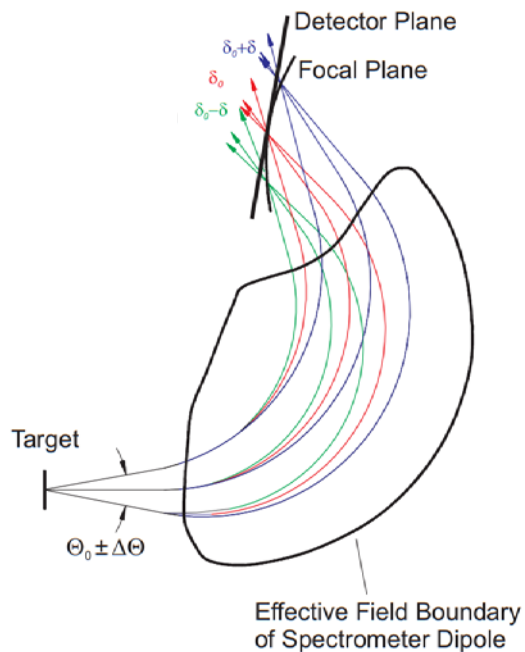
QCLAM Sieve Slit Measurement

- Needed for correction of curved focal plane

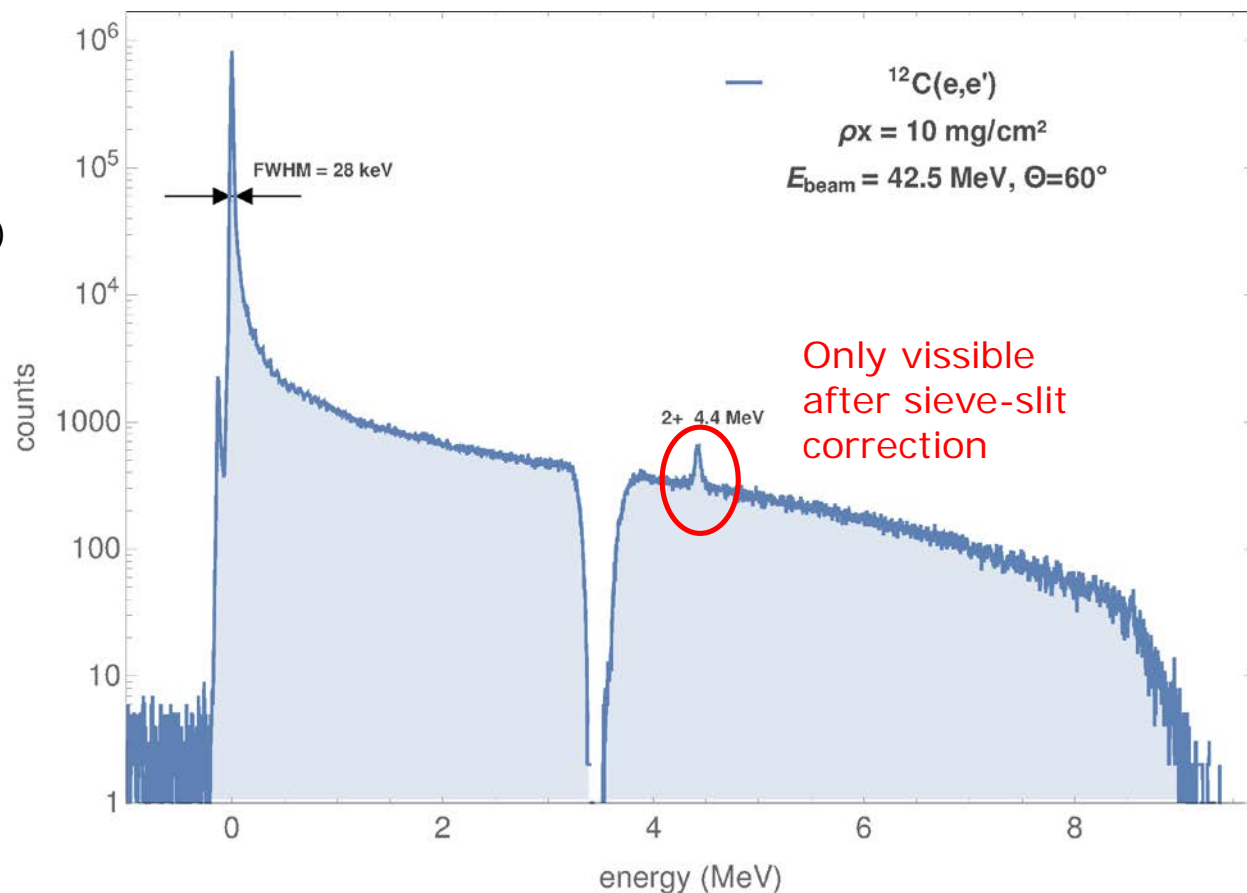
QCLAM ^{12}C Measurement

- Energy resolution:
 $6.6 \cdot 10^{-4}$
(best value so far: $7.6 \cdot 10^{-4}$,
Dissertation Hummel, 1992)
- Gap at ~ 3.5 MeV:
4 broken wires

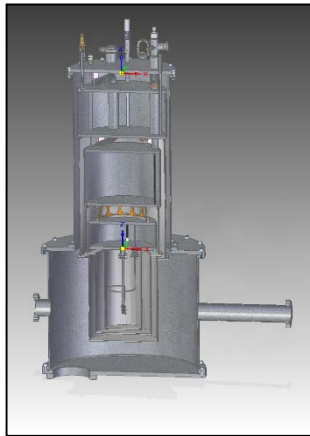
QCLAM ^4He Measurement

- Beam energy: 42.5 MeV
- Control of target thickness, no boiling-bubbles due to superfluid liquid helium

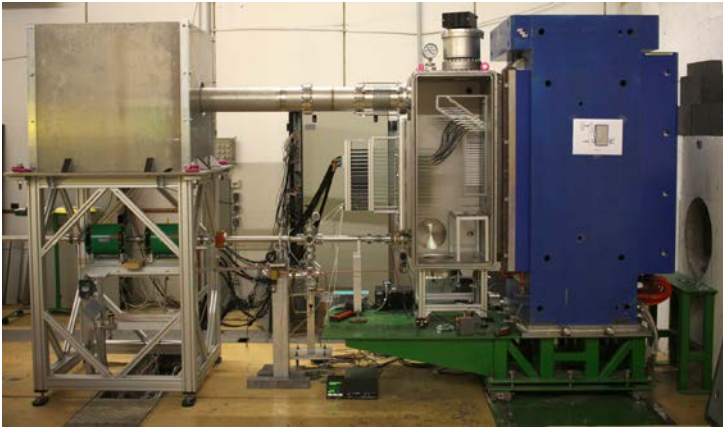
NEPTUN Commissioning 2018

- Completed commissioning runs with 68 and 65 MeV e- beams
- 1st run (August 2018) with 20% of the new focal plane detectors
- 2nd run (December 2018) with complete focal plane
- Investigated the response of large CeBr detector to high energy gamma rays
- Tagged 8125 keV 1^+ state in ^{32}S ;
- Performed first test of the setup for photoabsorption experiment (PROTEUS)

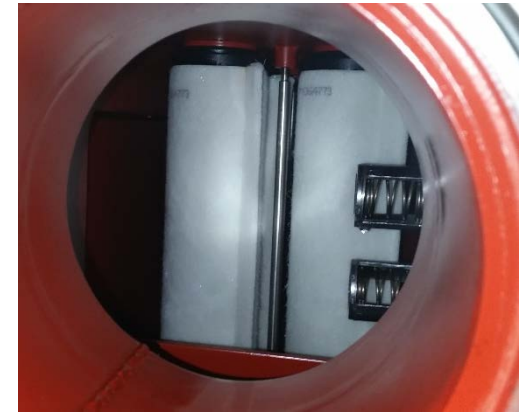
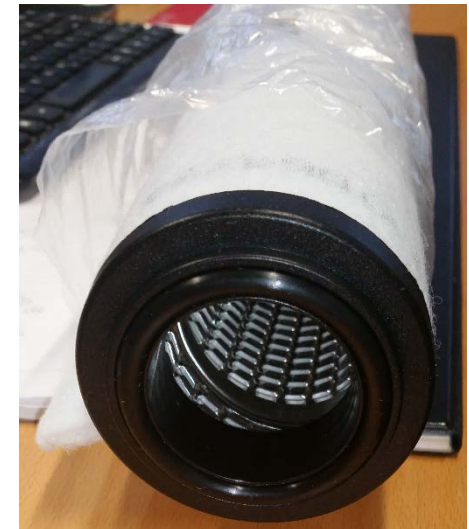
Leybold Pumping Stages

- Filter elements (4x14) have been replaced beginning of 2018
- ~ 8 weeks after start of operation: heavy oil loss of modules → too much oil at compressor
- Situation was controllable (refilling of oil at pumping stages, releasing of oil at compressor), contamination with oil was expected
- To ensure beam time for CRC: continuation of operation
- Information given to Leybold:
August/September 2018

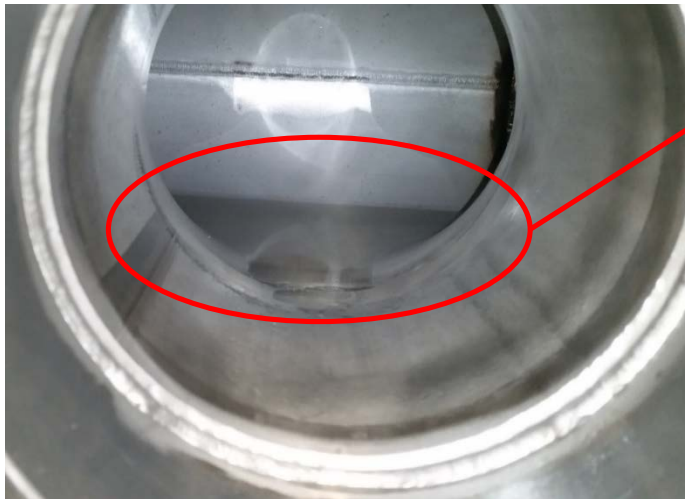
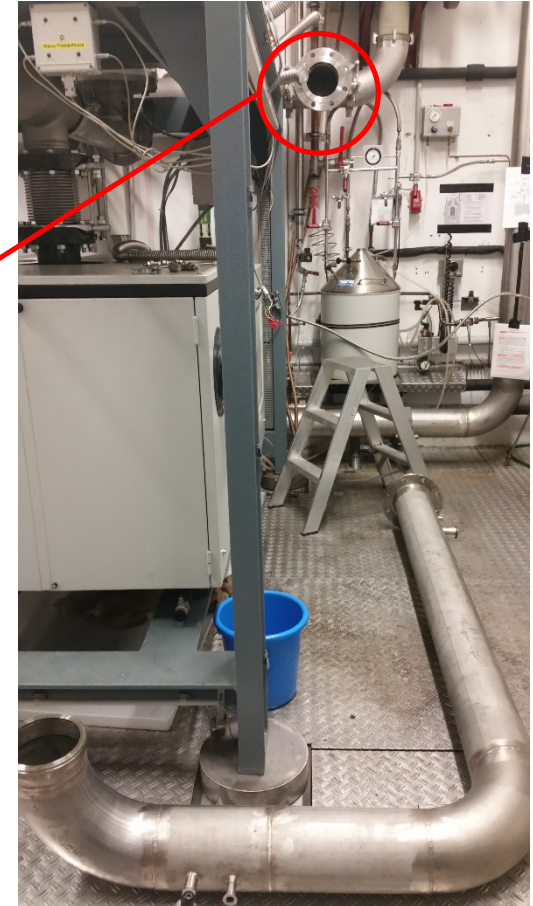
Leybold Pumping Stages

- Huge contamination of pipings with oil
- Causing a risky warm-up procedure in December 2018
- ~ 6 weeks of work to get rid of the oil contamination

- New filter elements installed by Leybold (but the same version)
- Guess by IKP: aggressive Breox oil is destroying glue/plastic parts of filter elements
- Long-term tests at Leybold to solve problem
- **Problem not fixed yet!**

- Stop of operation to protect machine
- Use new set of filter elements (hopefully improved version)
- Clean piping if necessary (< 6 weeks due to improvements)
- Continue operation

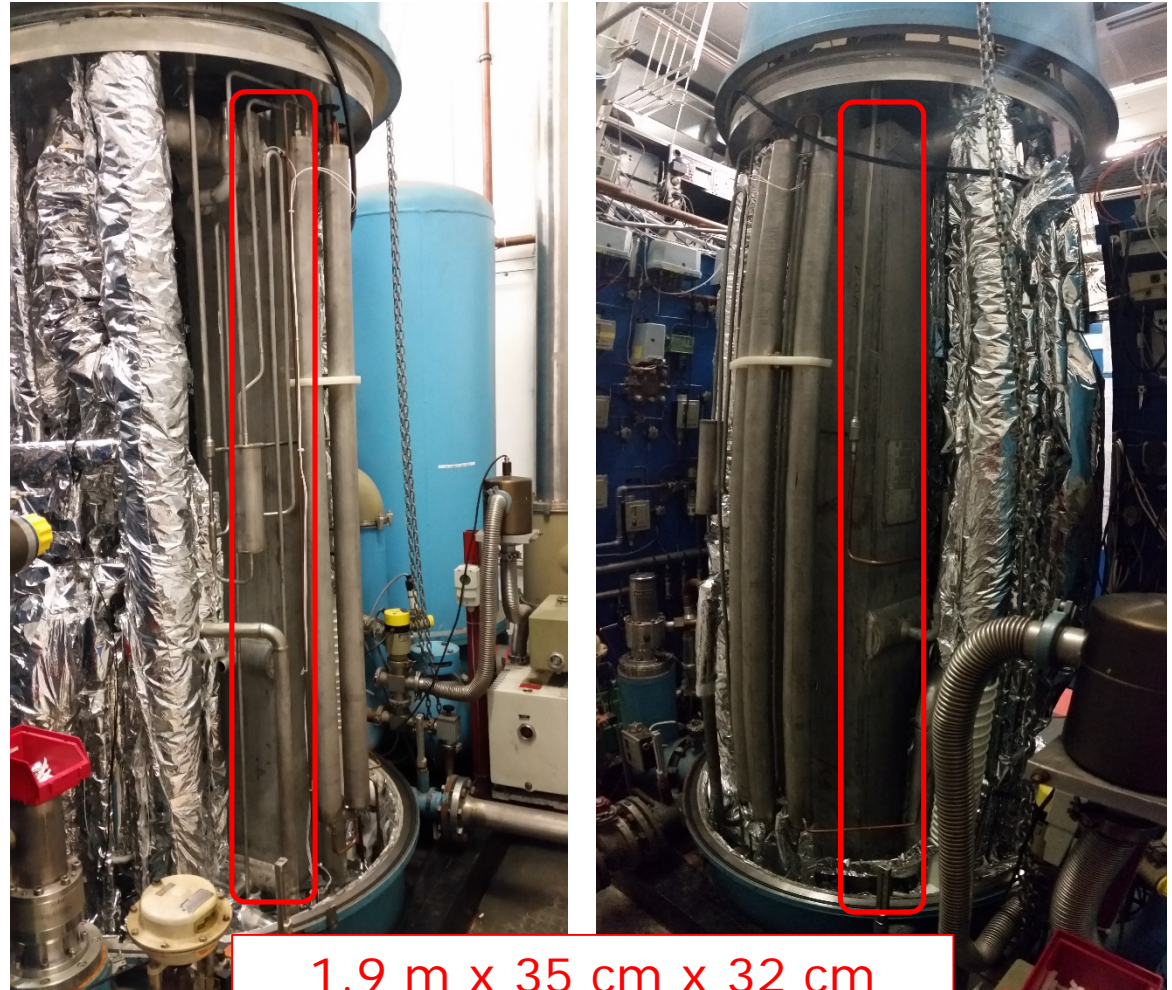
Heat Exchanger

- Most probably damaged during warm-up in Dec. 2018
- 4 leaks to insulating vacuum
- Tiny leak between high pressure and low pressure
- Very complicated to repair
- Replacement: delivery time of 8-9 months, 100 k€

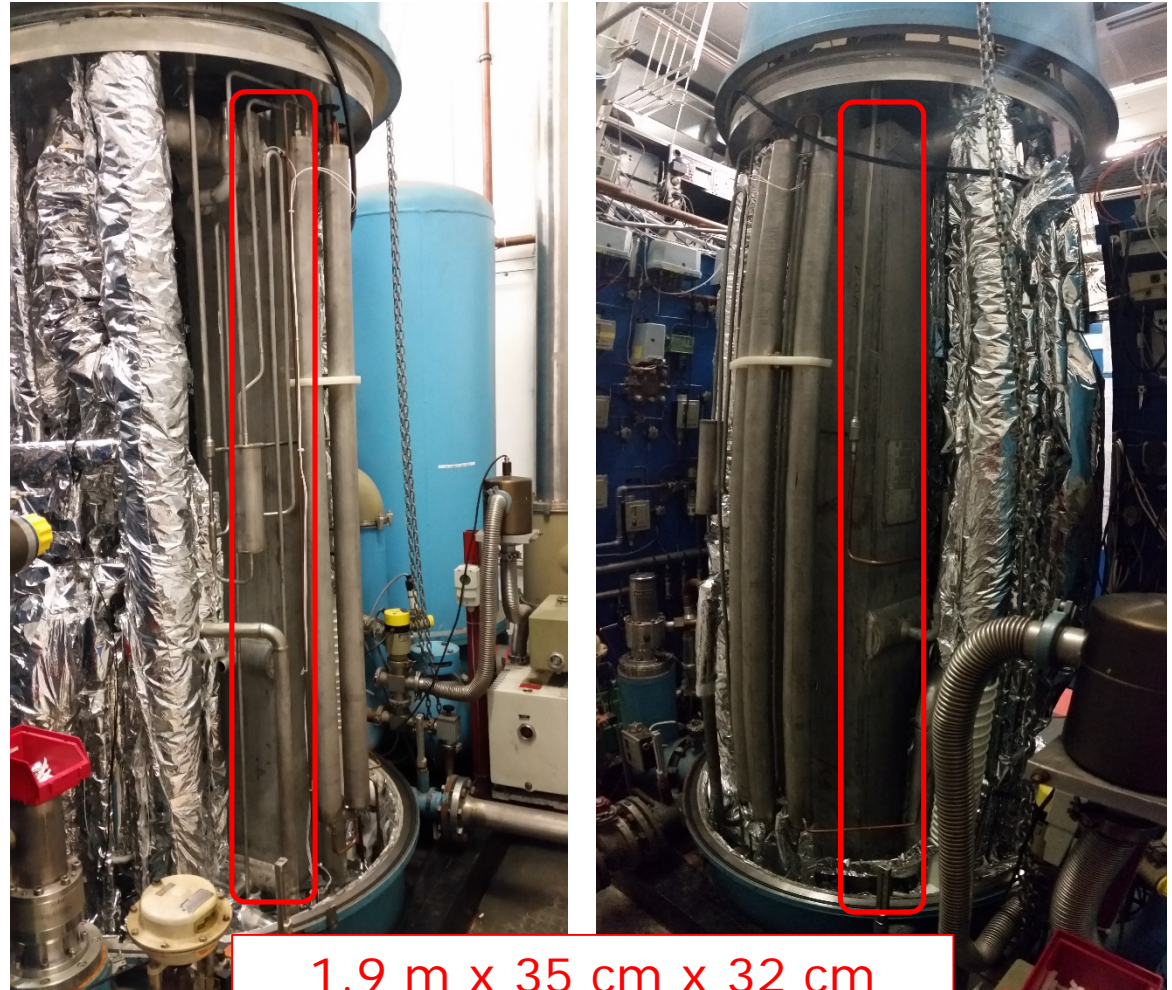
Heat Exchanger

- 4 leaks to insulating vacuum have been closed
- Tiny leak between high pressure and low pressure is irreparable
- Cool down to check if cryo plant is working and has enough cooling power
 - If yes: proceed
 - If no: done for the year

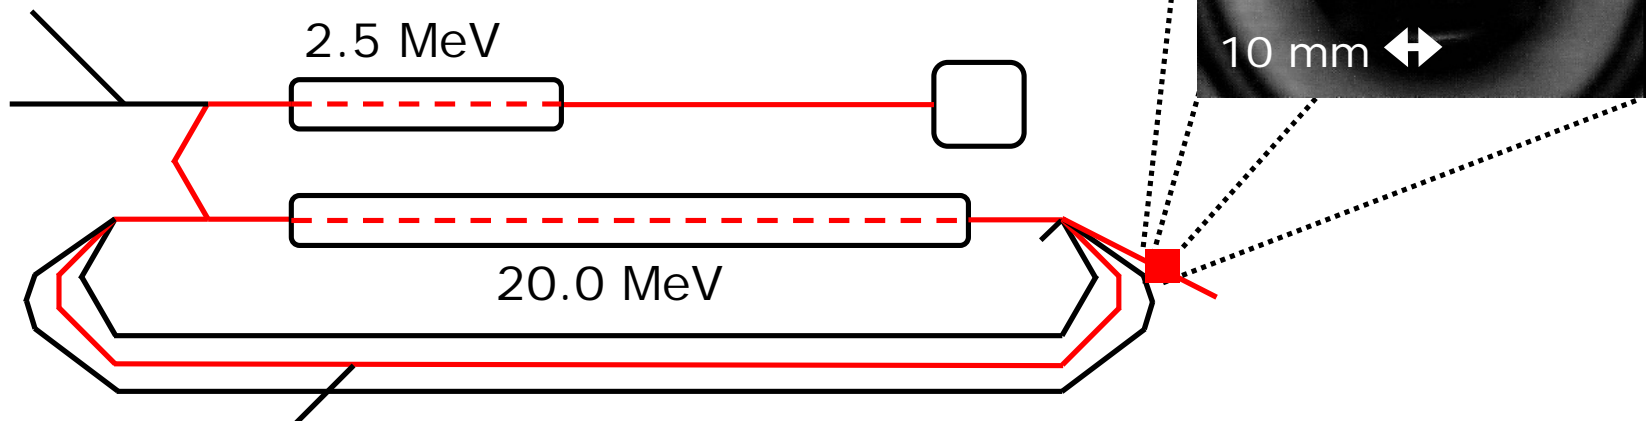
Once-Recirculating Operation

- Test of maximum beam current:
~98 % transmission to extraction
at design current for recirculating
operation (20 μA) \rightarrow new record
- Beam losses very small

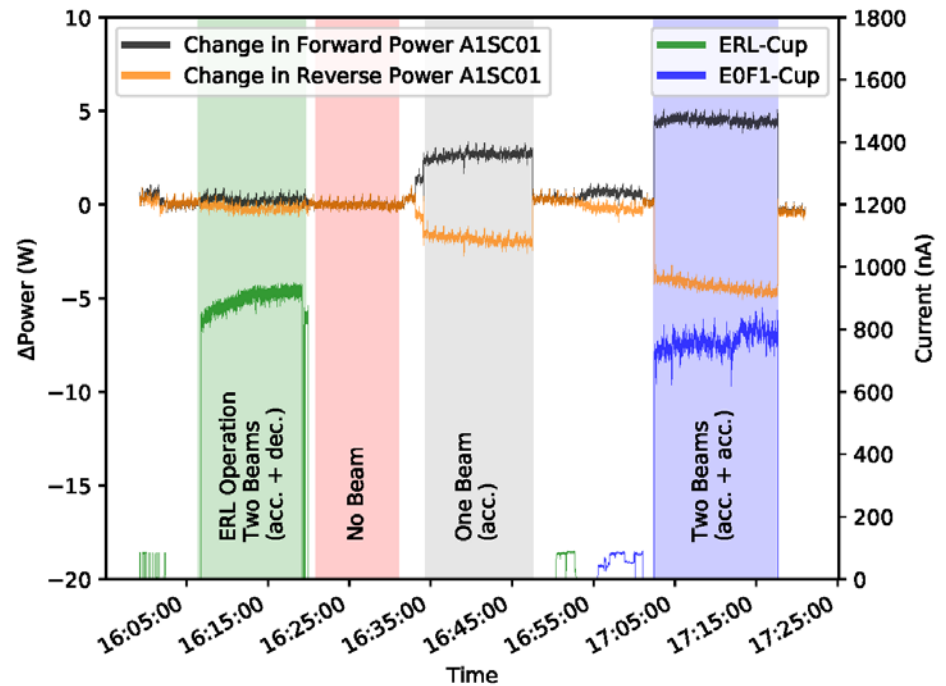
Once-Recirculating ERL Operation

August 2017:

First ERL in Germany!

- Energy gain injector: 2.5 MeV
- Energy gain LINAC: 20.0 MeV
- Current (before SRF): $\sim 1.2 \mu\text{A}$
